REPORT OF SEDIMENTATION SURVEY

LAKE WINTERS

RUNNELS COUNTY, TEXAS

1970

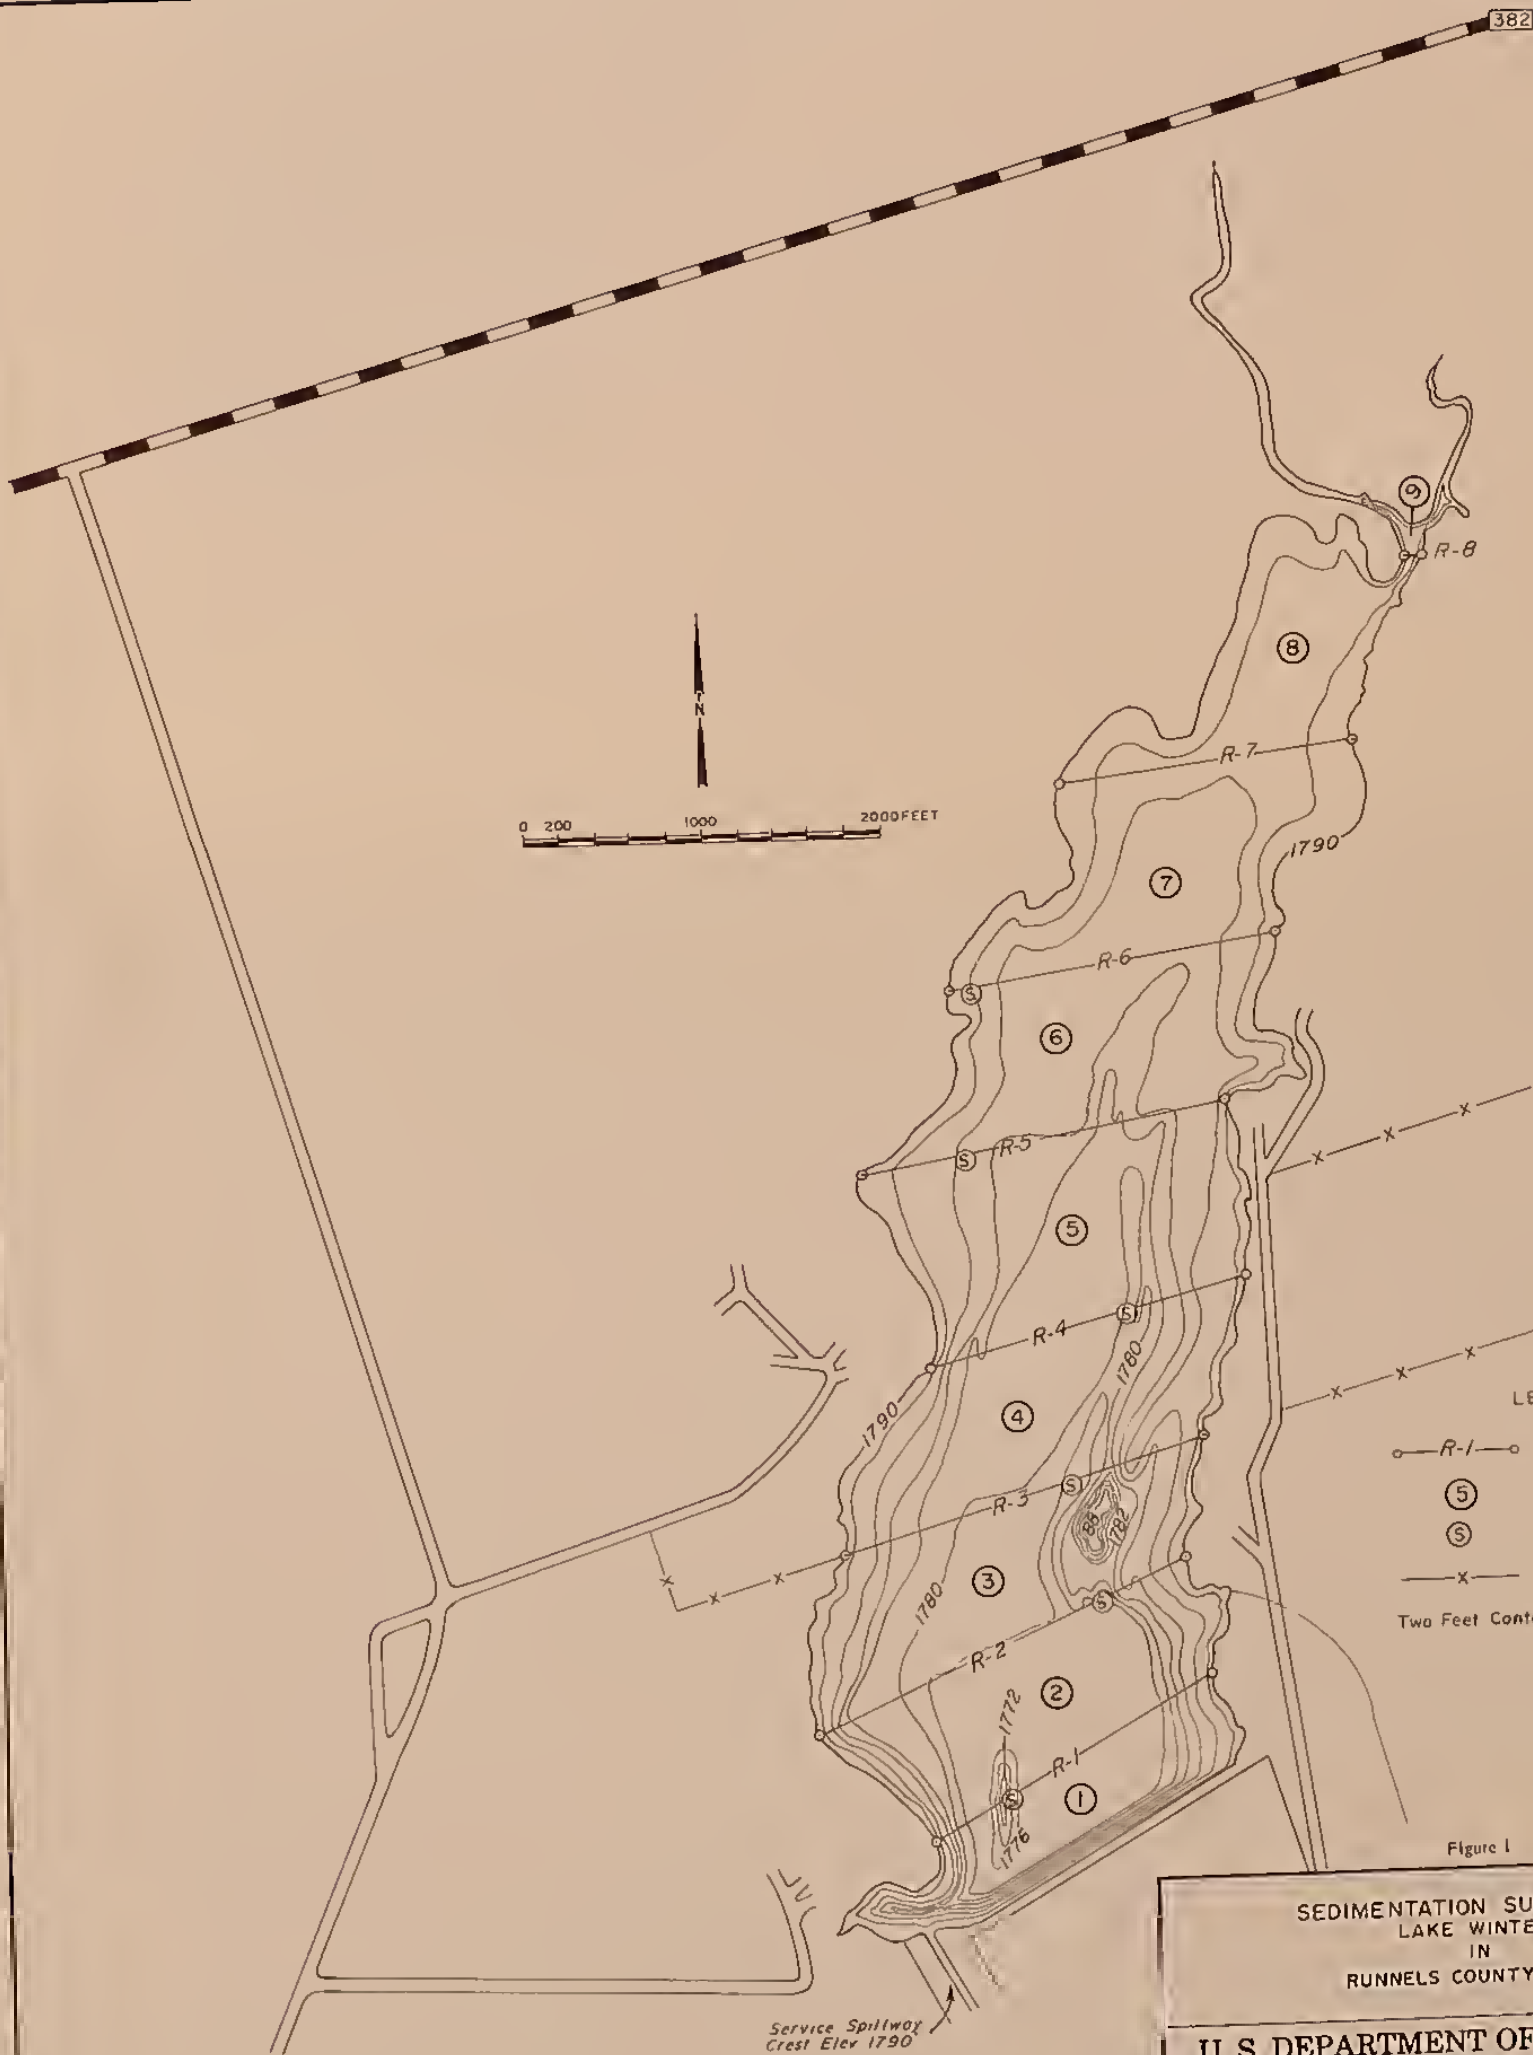
Figure 1

SEDIMENTATION SURVEY-1970
LAKE WINTERS
IN
RUNNELS COUNTY, TEXAS

Distribution of Sediment - As shown by the segment data, Table 2, capacity loss is relatively uniform throughout the first 7 segments. The greater capacity losses due to sediment are in segments 8 and 9, at the upper end of the reservoir. As the water level of the lake drops during times of low rainfall and runoff, these upper segments have the largest proportion of shallow water or dry areas in the lake. This situation is conducive to accelerated growth of aquatic weeds and other vegetation which slows the flow of water and thus increases the deposition of sediment. The reservoir, to date, has lost 25 percent of its original capacity.

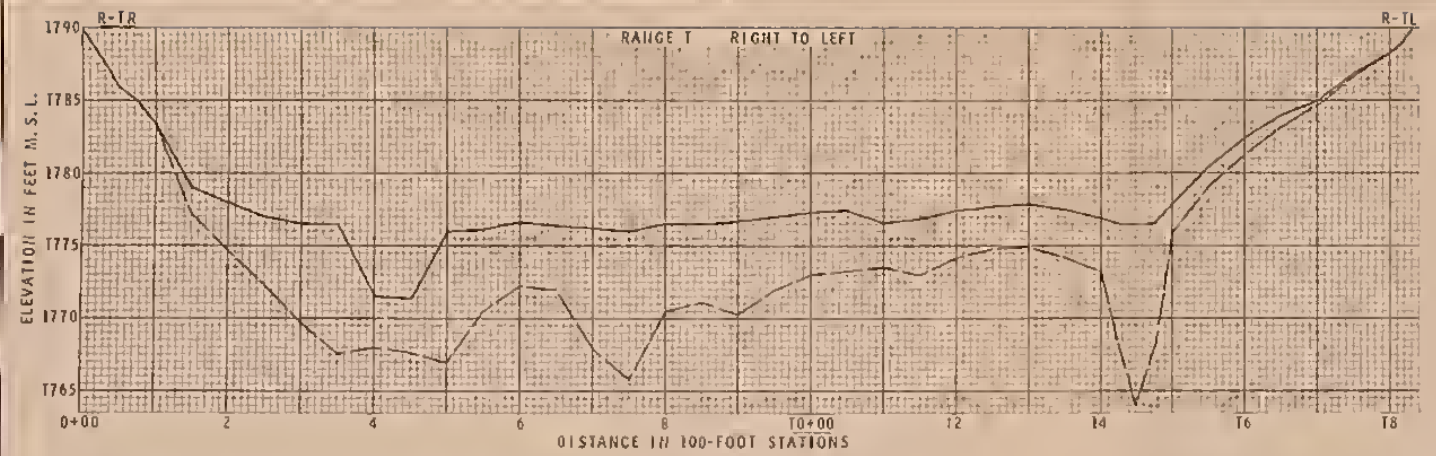
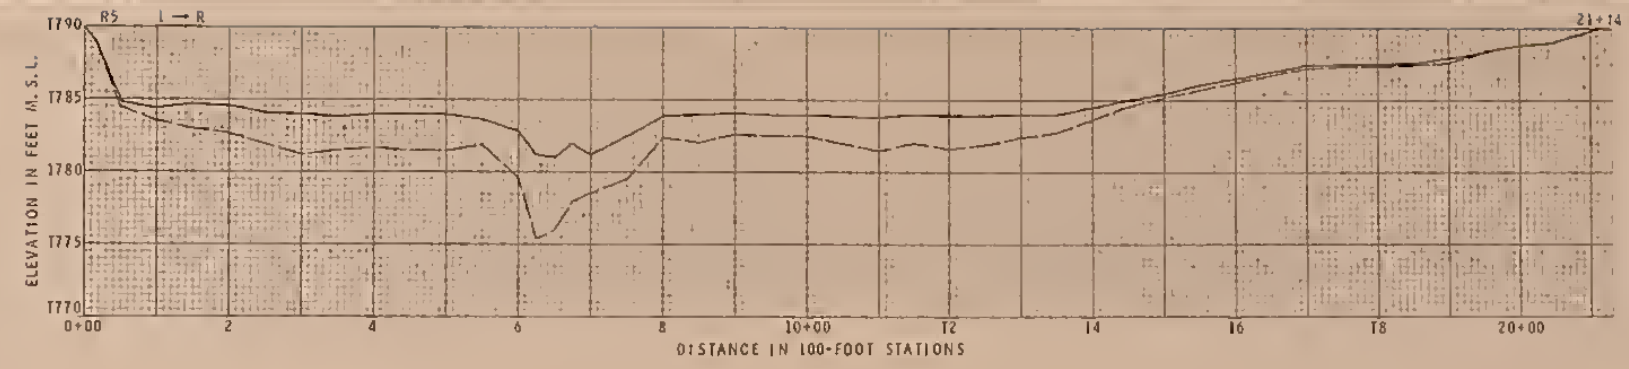
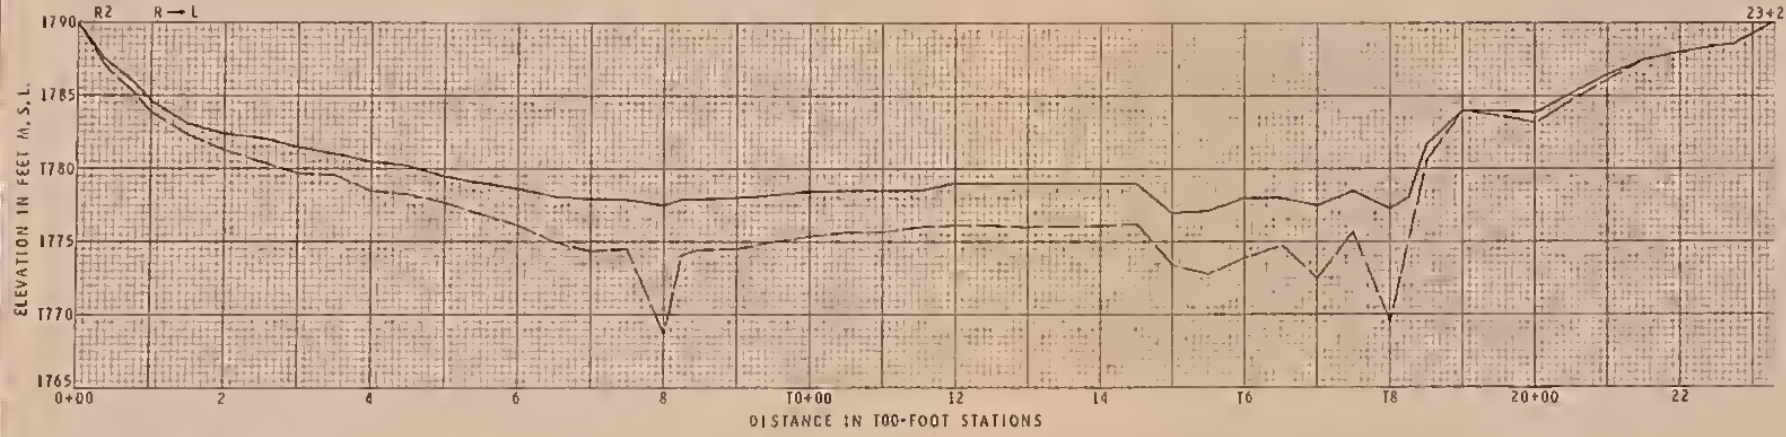
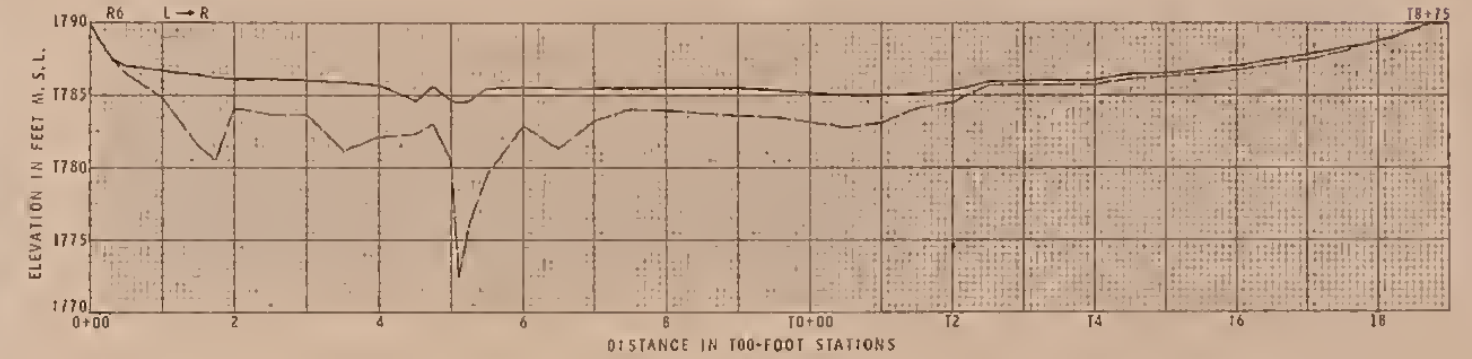
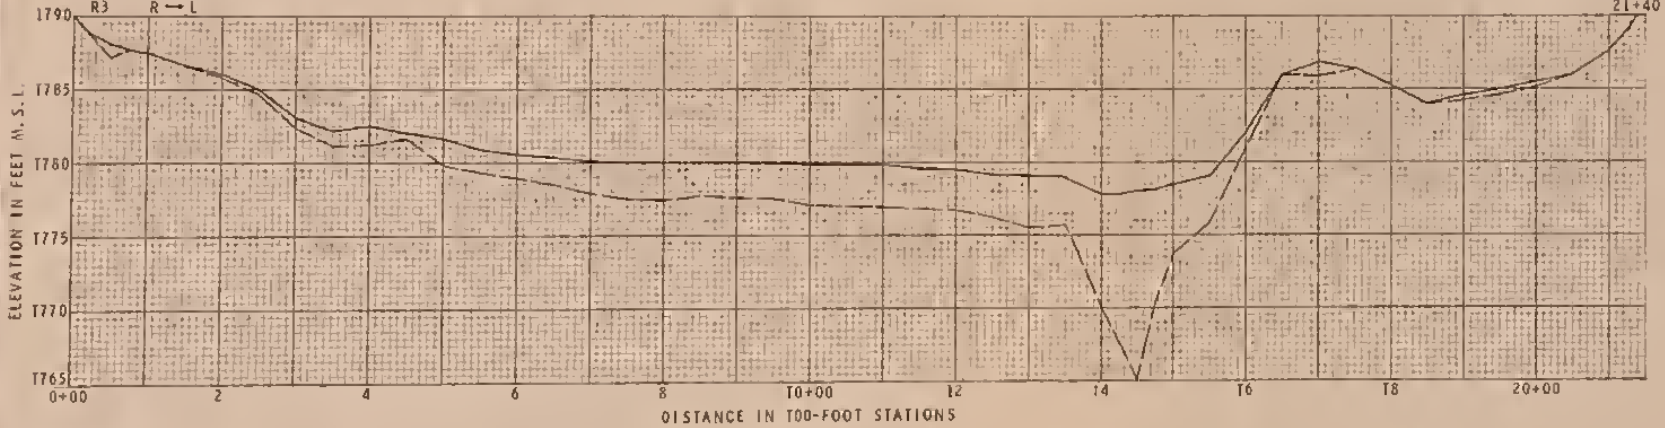
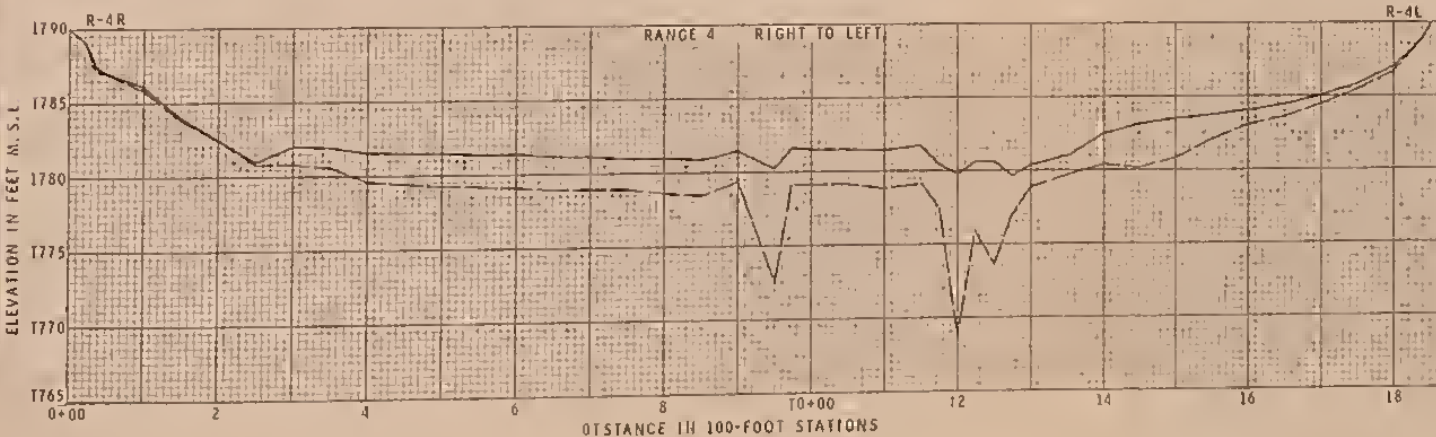
Figure 3

Plottings of representative range cross sections showing the original and present elevations are shown in figure 3.

RANGE CROSS SECTIONS SEDIMENTATION SURVEY - 1970 LAKE WINTERS RUSSELL COUNTY, TEXAS	
U. S. DEPARTMENT OF AGRICULTURE SOIL CONSERVATION SERVICE	
Approved by District Engineer Date	Checked by District Engineer Date
Drawn by Date	Plotted by Date
4-R-30,153

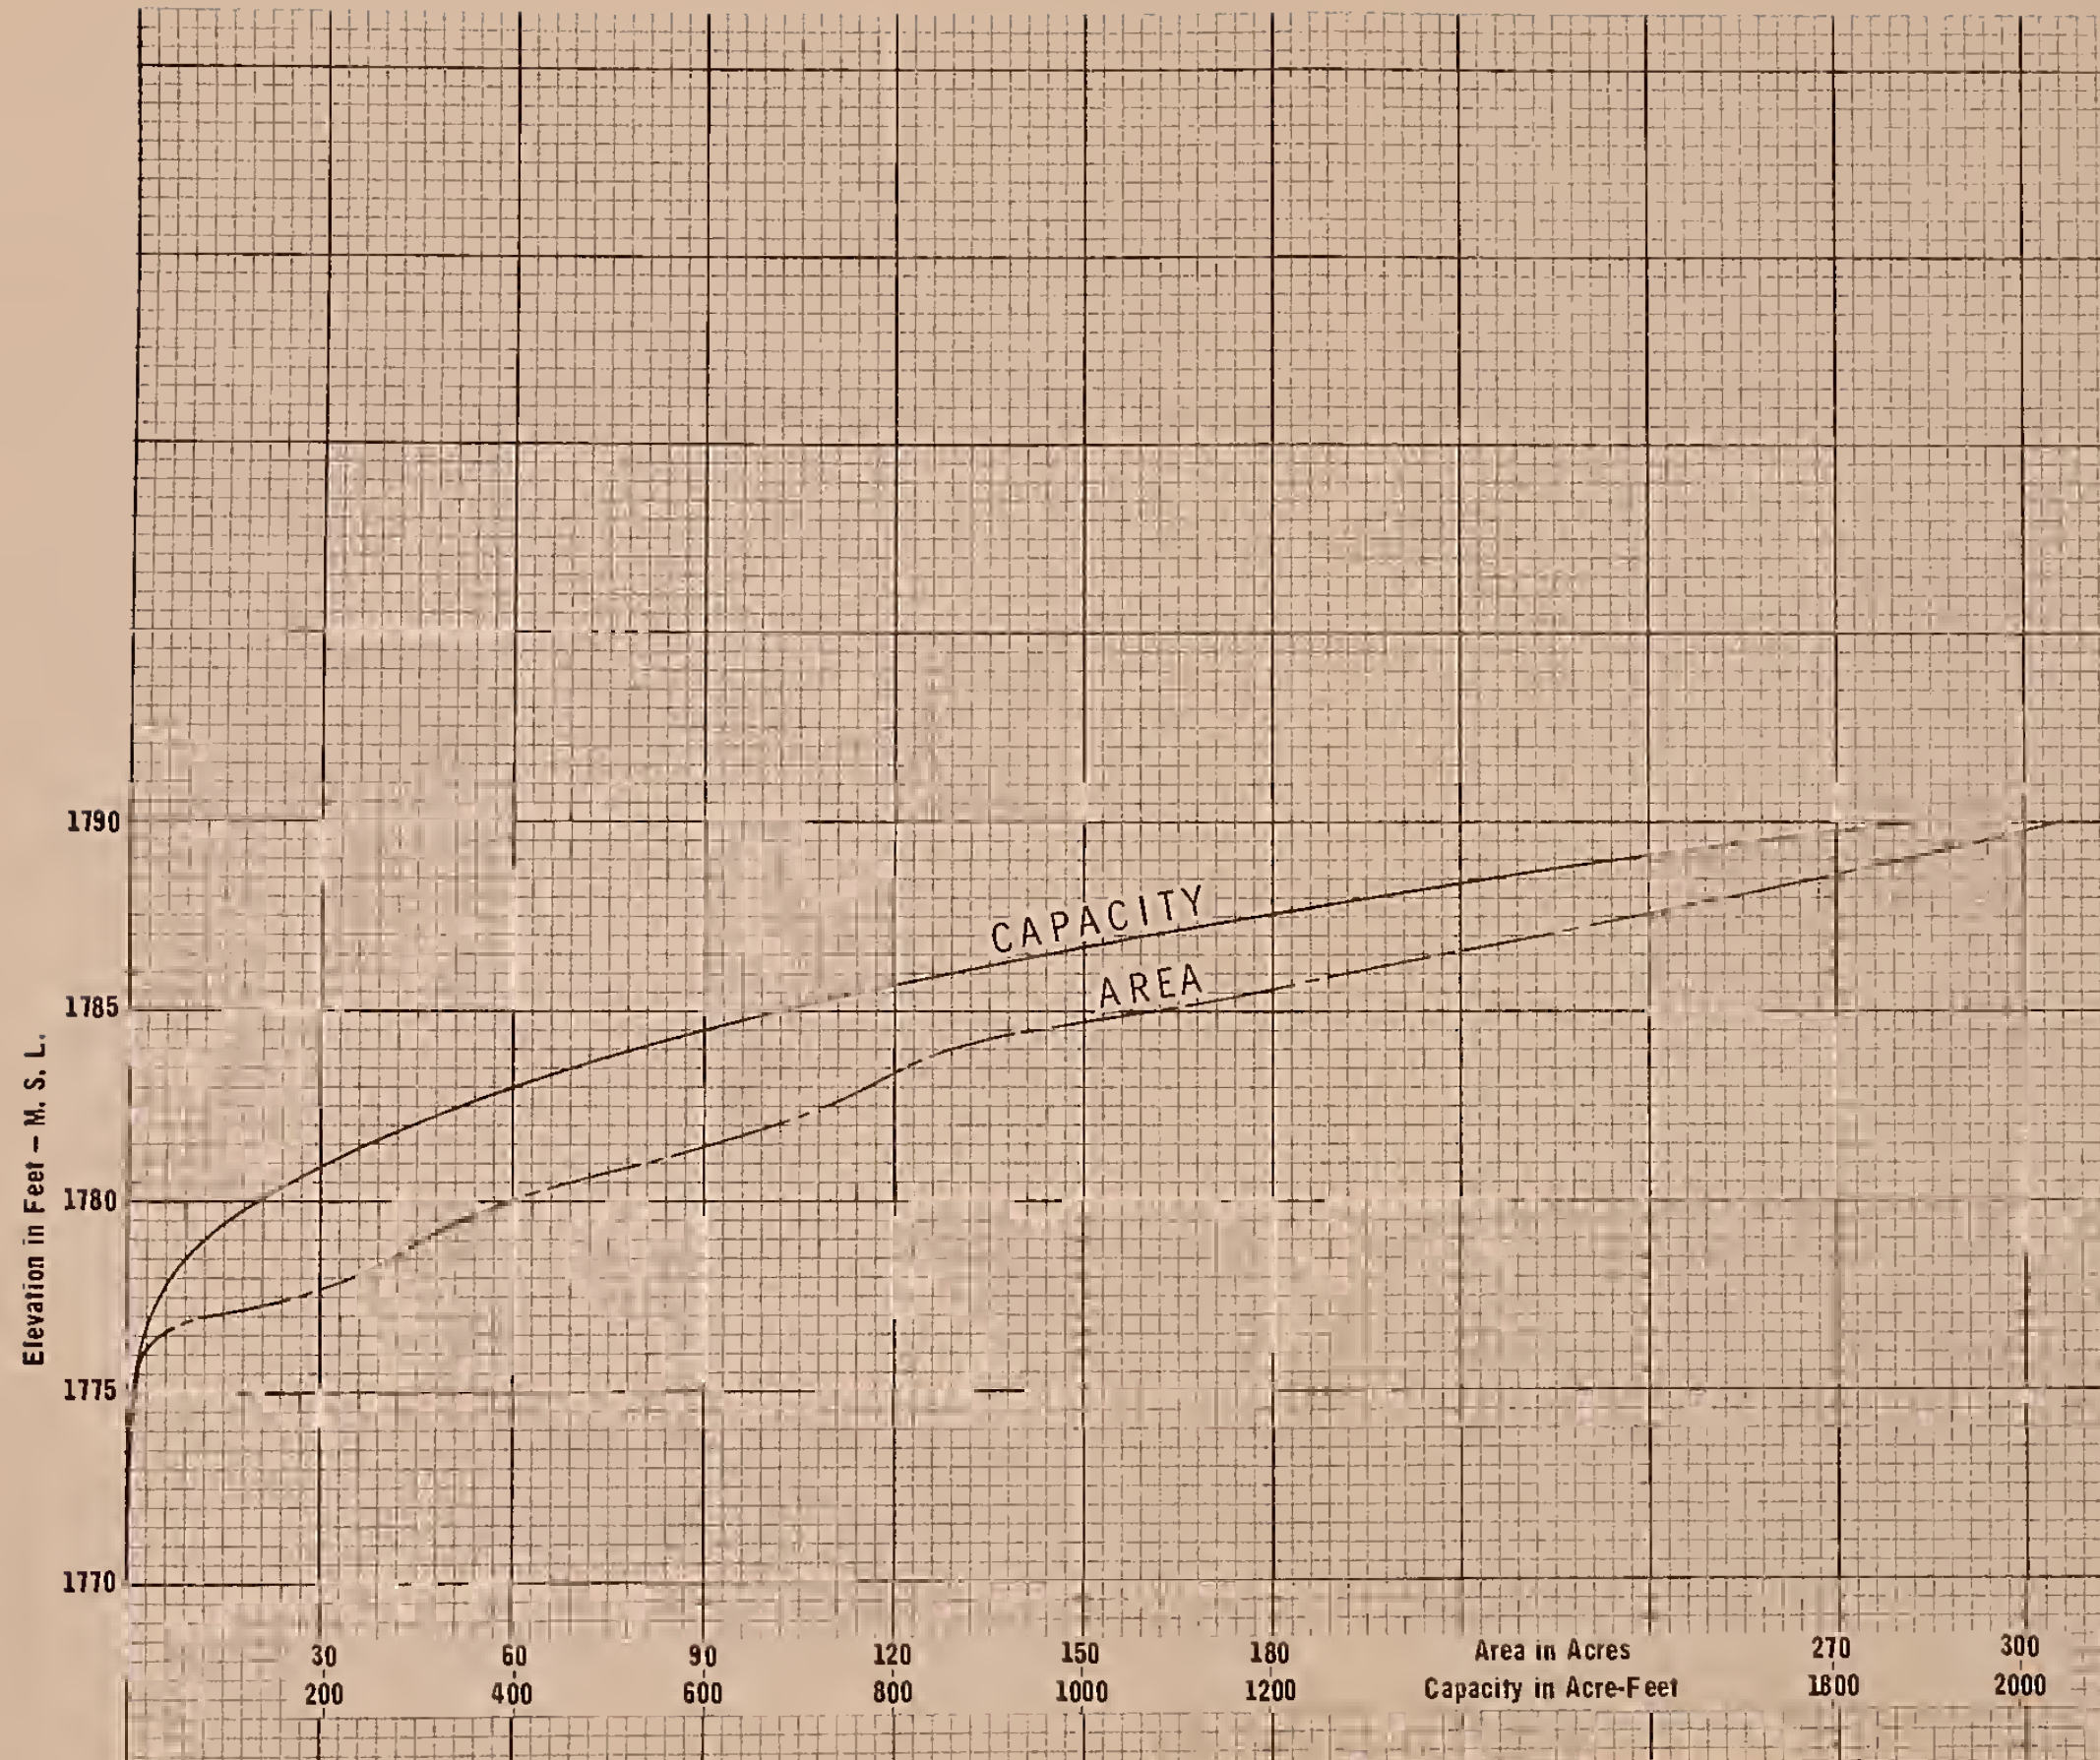
Figure 4

Area and capacity curves were constructed using a contour map plotted from the present water depth measurements taken during this survey. (See figure 4.)

AREA AND CAPACITY CURVES LAKE WINTERS IN RUNNELS COUNTY, TEXAS			
U. S. DEPARTMENT OF AGRICULTURE SOIL CONSERVATION SERVICE			
Designed <u>R.H.Z.</u>	Date <u>2-71</u>	Approved by _____	
Drawn <u>W.D.B.</u>	Date <u>2-71</u>	Title _____	
Traced <u>F.I.B.</u>	Date <u>2-71</u>	Title _____	
Checked <u>J.W.M.</u>	Date <u>2-71</u>	No. <u>1</u>	Drawing No. <u>4-R-30,149</u>
		of <u>1</u>
